## Nanolime consolidation of the main building stone of the archaeological site of Volubilis (Morocco)

Dalal Badreddine, Kévin Beck, Xavier Brunetaud, Ali Chaaba, Muzahim Al-Mukhtar

Dalal Badreddine, Kévin Beck, Xavier Brunetaud, Ali Chaaba, Muzahim Al-Mukhtar. Nanolime consolidation of the main building stone of the archaeological site of Volubilis (Morocco). *Journal of Cultural Heritage*, 2020, 10.1016/j.culher.2019.12.006 . hal-02476671

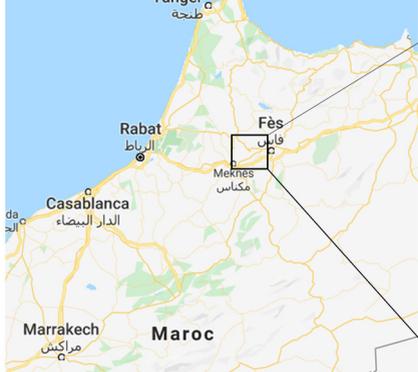
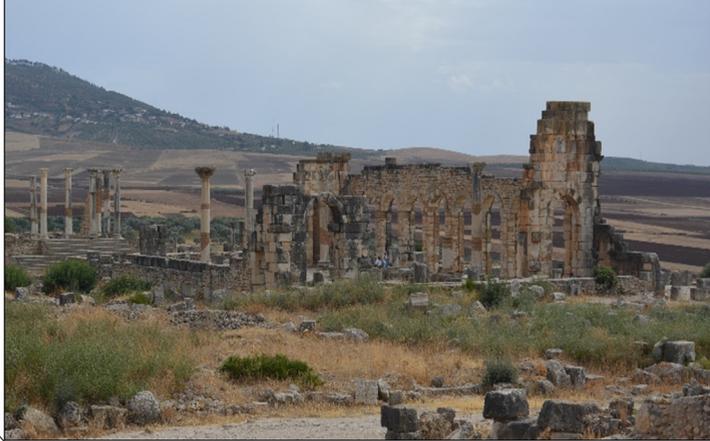
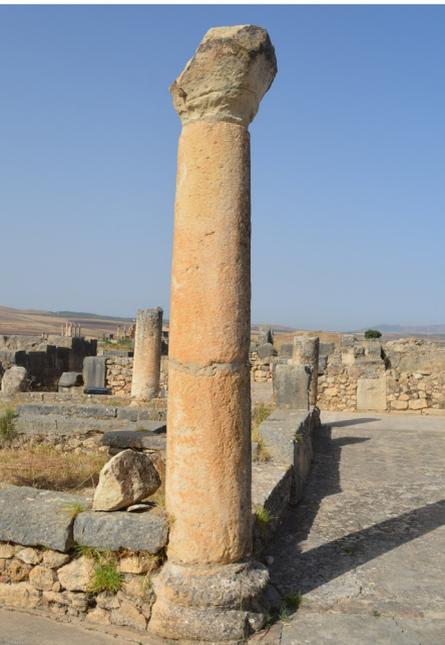
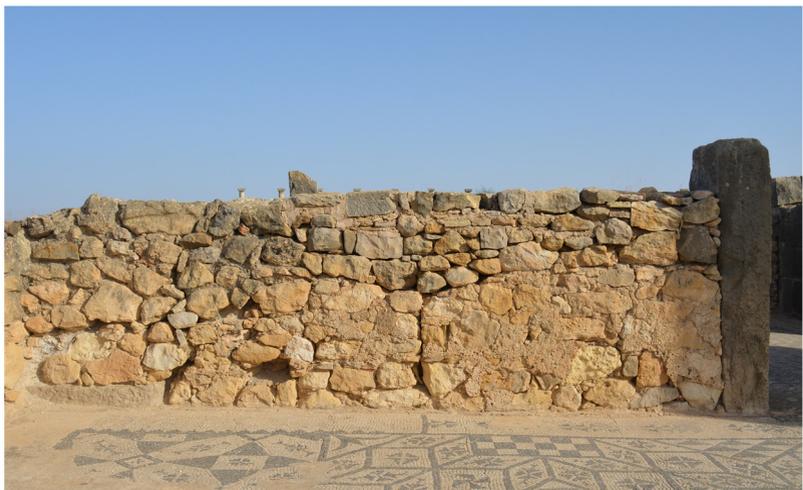
*Figure 1: (a) Geographical location of the archeological site of Volubilis, (b) calcarenite stone used as wall rubble and (c) as carved architectural elements*

The main objective of this research was to study the efficiency of nanolime as a consolidation treatment of a weathered limestone called calcarenite. Calcarenite is the main building stone of the archeological site of Volubilis, a world heritage site [1] located 30 km north of Meknes city in Morocco (figure 1).

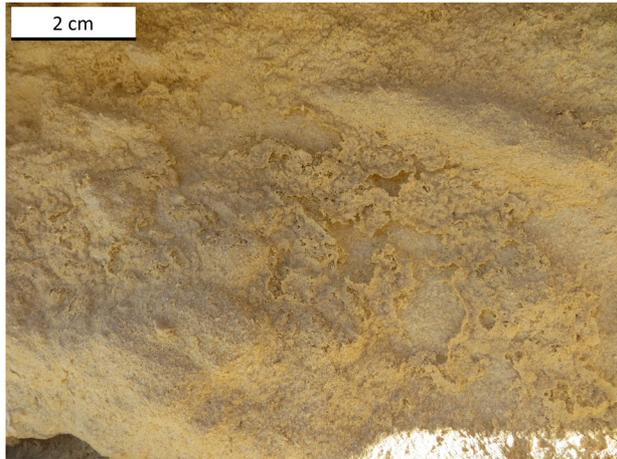
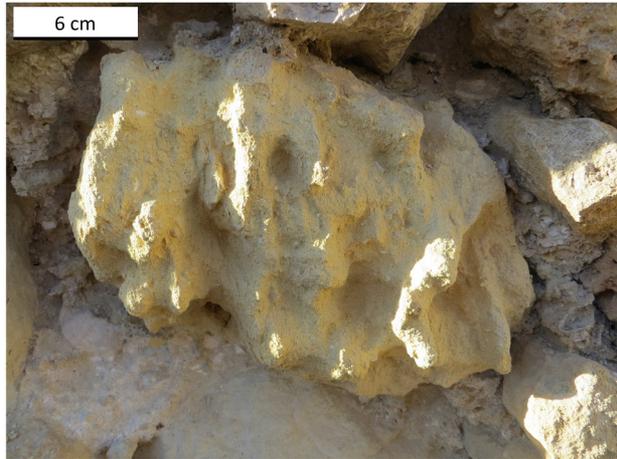
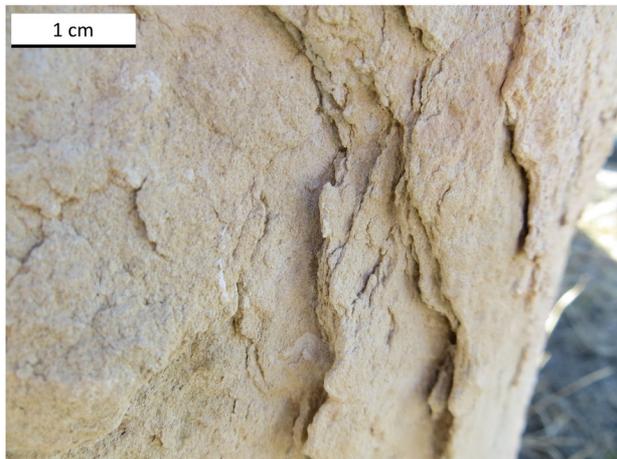
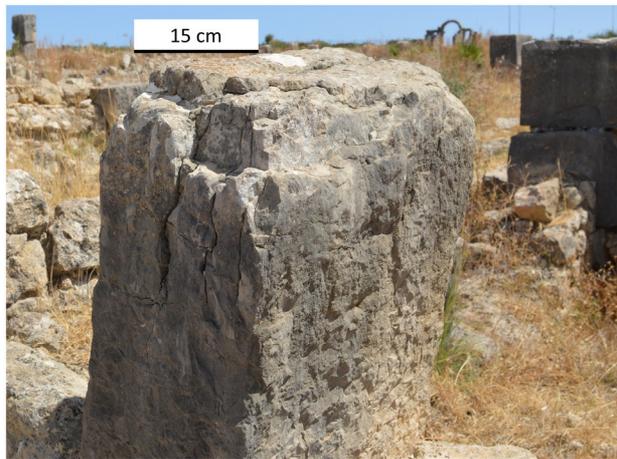
*Figure 2: Degradation patterns on the site of Volubilis*

Sanding

Alveolization

Scaling

Cracking

Over the years, exposure to aggressive environmental conditions has caused substantial damage to the site's monuments. The damage has affected the site on two levels: structural disorders that occurred after the Lisbon earthquake in 1755 [2], which caused the collapse of most of the monuments, and disorders that affect the building materials (stones and mortar). According to the ICOMOS glossary-illustrated figures of alterations of the stone [3], the degradation patterns observed in situ can be divided into two categories: biological colonization that alters the aesthetic aspect of the stone and degradation patterns that cause a loss of matter. The latter includes sanding, scaling and alveolization that are due to the crystallization of destructive salts originated in some of the restoration mortars and transported to the stone porosity by water transfer [4], as well as cracking that is caused by climatic variations [5].

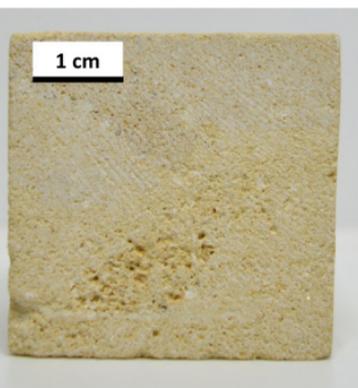
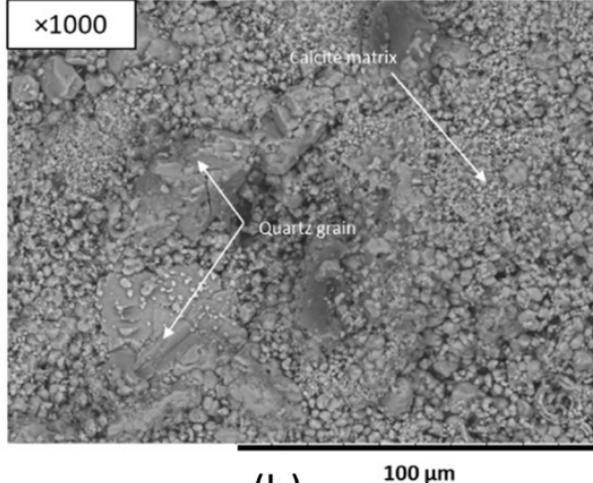
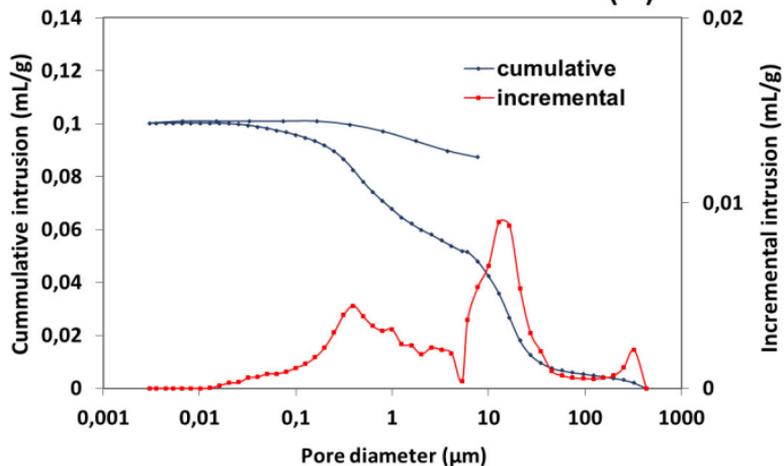
*Figure 3: (a) Calcarenite stone from Ain Schkor quarry (cubic sample  $4\times 4\times 4\text{ cm}^3$ ), (b) microscopic image of the calcarenite ( $\times 1000$ ) and (c) pore size distribution of the calcarenite stone*

Calcarenite stone is the main building stone of the archeological site of Volubilis, representing over 60% of the volume of the site's building stones. It was usually recovered from Ain Schkor quarry, located within 5 km of the site. Calcarenite is a beige-yellowish limestone rich in terrigenous material and large bioclasts [24] containing mostly calcite and quartz [4]. The stone has an average porosity of 19%, close to that of the San Julian calcarenite [25] and lower than other calcarenite like the Maastricht calcarenite (40 to 52% of porosity) [26], the Marsala calcarenite (40 to 60% of porosity) [27] or the Tamala calcarenite (30 to 50% of porosity) [28]. The calcarenite has a bimodal distribution with two distinct pore families: a first principal peak is observed around the pore diameter equal to 20  $\mu\text{m}$ , this type of pores represents the macroporosity, estimated at 52%. The second peak is between 0.1 and 0.3  $\mu\text{m}$ , this type of pores is the mesoporosity of the stone, estimated at less than 27%. The Calcarenite of Volubilis has a capillary coefficient of  $2.03 \text{ kg/m}^2/\text{h}^{0.5}$ , and compressive strength of 18.45 MPa. Compared to the previously cited calcarenites, the presently tested calcarenite has a higher compressive strength than the Marsala stone (1.2 to 4 MPa) [27], lower than the san Julian calcarenite (38 MPa) [29]. The Maastricht calcarenite has a wide compressive strength range (5 to 20 MPa) [30]. The presently studied calcarenite is visibly a heterogeneous stone, composed of two distinct parts: a yellow, visibly more porous, part and a white, more compact part (figure 3). Calcarenite has an average ultrasound velocity of 2751 m/s, but due to its apparent heterogeneity, it has an anisotropy index of 15% [31] which indicates that the velocity is higher in a certain direction. The microscopic image of the

calcarenite, taken with a scanning electron microscope Hitachi TM-3000, shows a compact matrix (formed of calcite) surrounding angular quartz grains with a diameter of approximately 100  $\mu\text{m}$  [31].

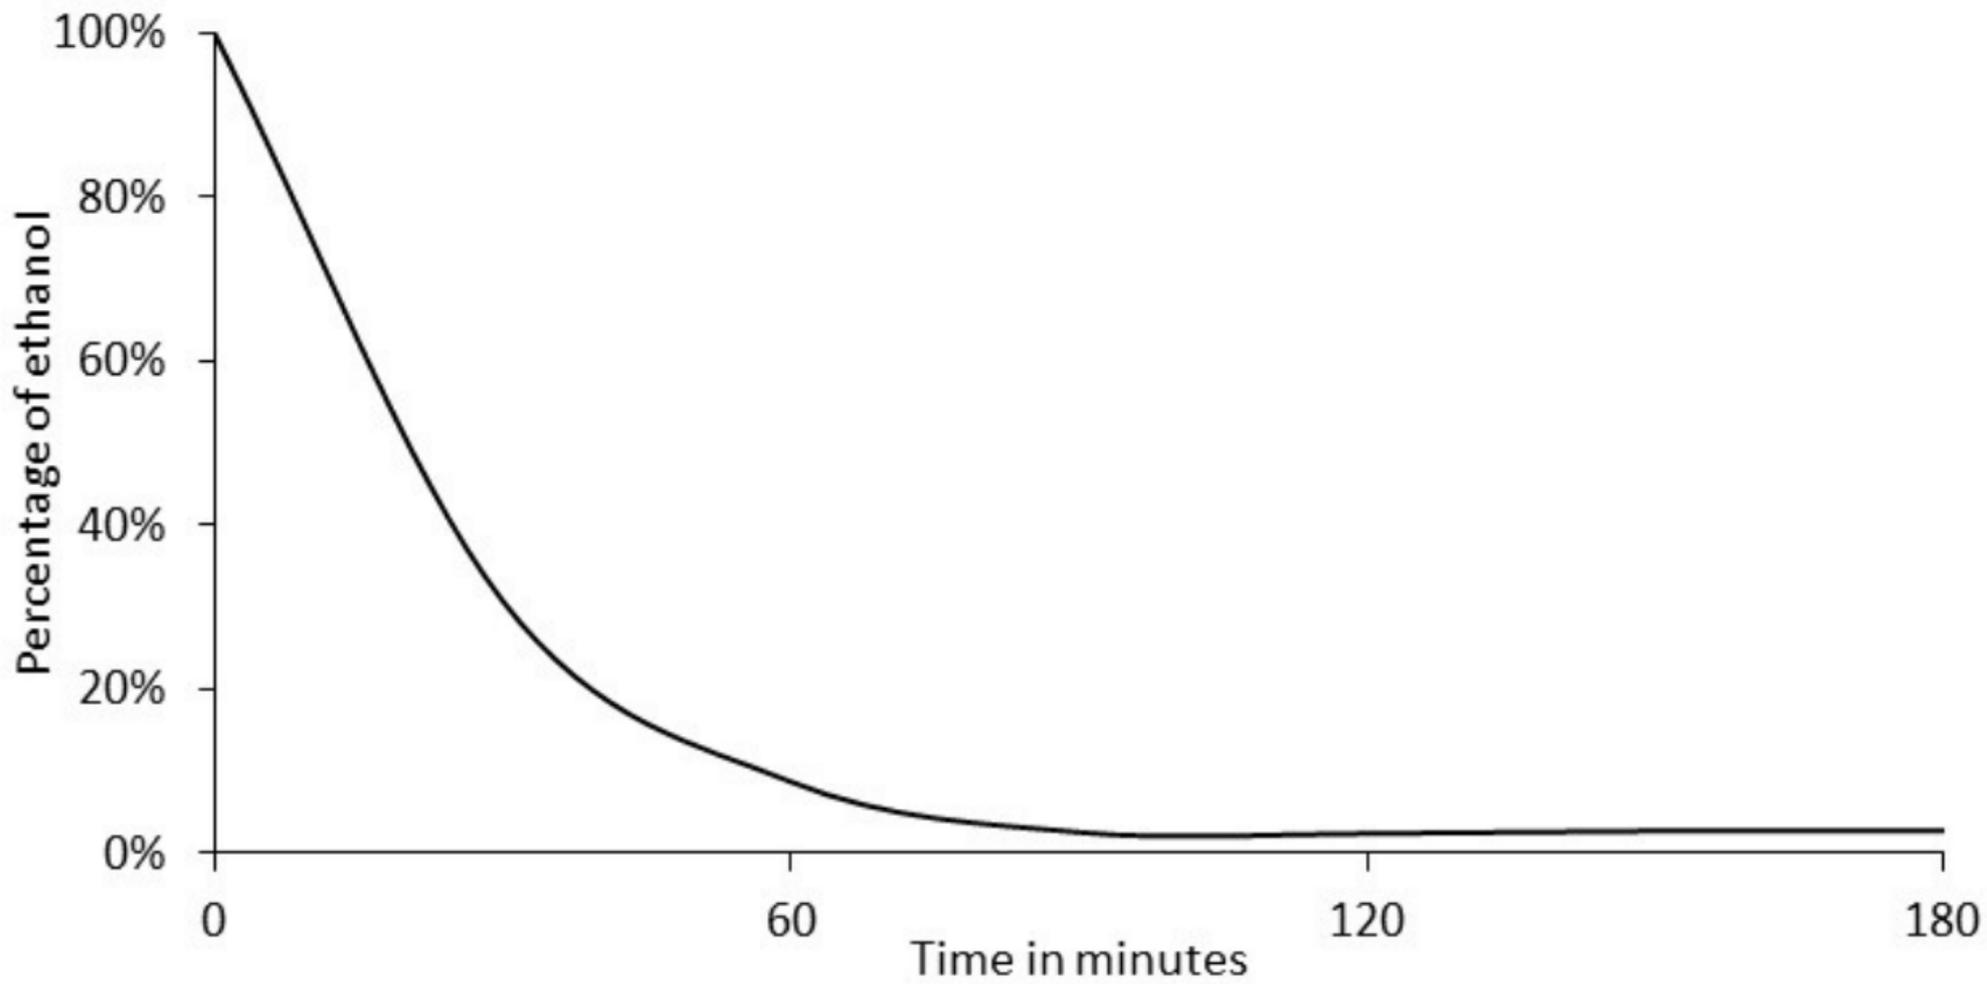
*Figure 4: Drying curve of a calcarenite sample treated with ethanol*

To improve the consolidation effect of the treatment, the product is applied more than once. The optimal number of applications ultimately depends on the stone porosity and pore size [35]. Slizkova et al. [21] showed that after the first three applications of CaLoSiL E50 on a highly porous stone such as the Maastricht stone (with an average porosity of 50 %), the water movements became slower, which indicates partial saturation of the pore space. Due to the lower porosity of calcarenite stone (19 %) compared with Maastricht stone, the product was applied three times to the stone [36]. A higher number of applications would not be as effective as  $\text{Ca}(\text{OH})_2$  particles would quickly fill the pore space. To define the interval between two consecutive applications, a preliminary test was conducted on a cubic sample of calcarenite stone ( $4 \times 4 \times 4 \text{ cm}^3$ ) to determine the time required for the ethanol in the stone sample to dry. Ethanol was applied by brushing to the surface of the stones, that were placed in a controlled environment ( $20 \text{ }^\circ\text{C}/76 \text{ \%HR}$ ). The drying curve (figure 4), evaluated by measuring the weight loss over time, shows that ethanol was almost entirely evaporated after 90 minutes. The interval between two consecutive applications was defined as 3 hours. All measurements were performed after 28 days of curing [20-37]. During this time, the specimens were placed in a controlled environment, with a temperature of  $20^\circ\text{C}$  and relative humidity of 76 %, to enhance the carbonation process and ensure maximum conversion of  $\text{Ca}(\text{OH})_2$  into  $\text{CaCO}_3$  [38].

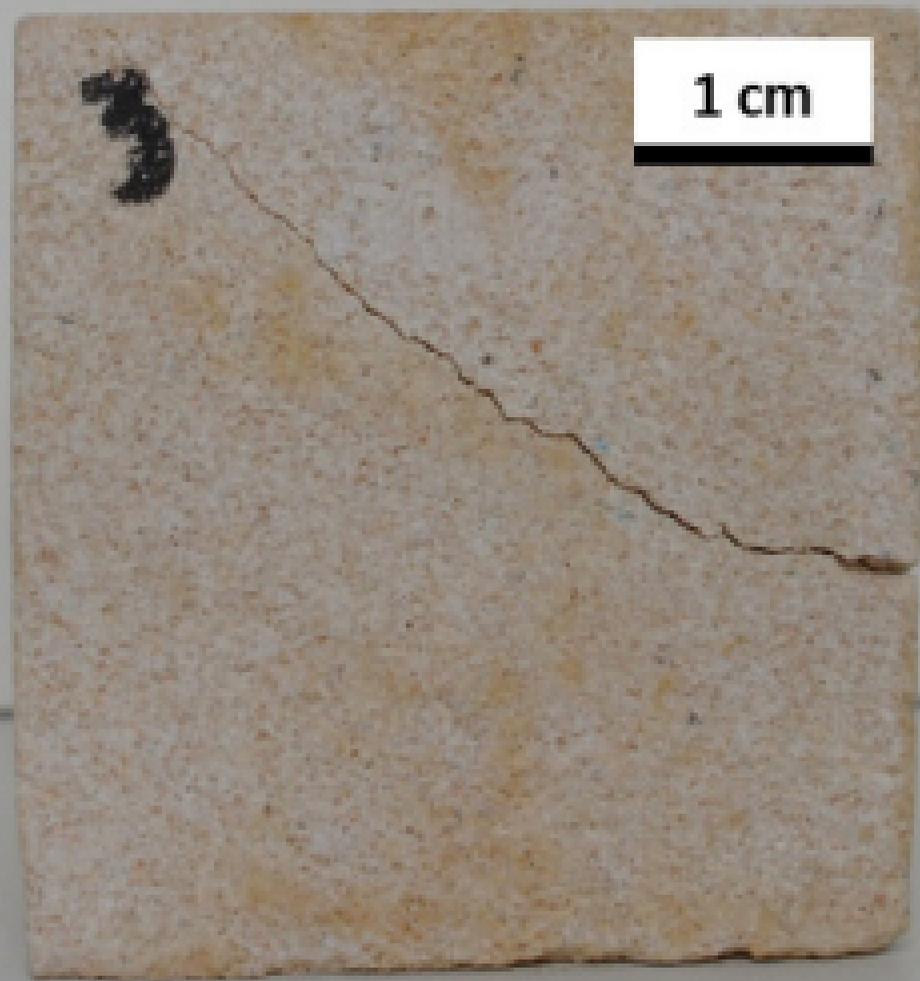
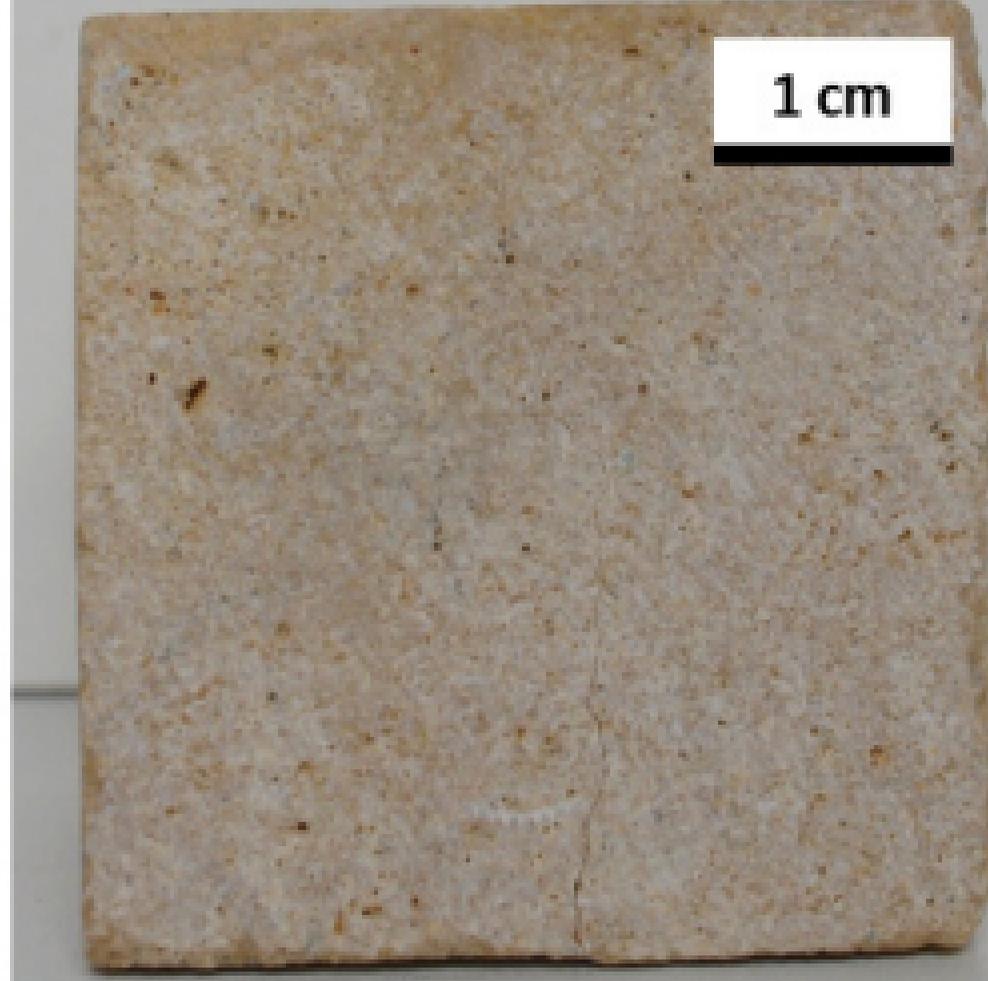
*Figure 5: Cracked calcarenite stone samples due to thermal shock aging test ( $4 \times 4 \times 4$  cm<sup>3</sup>)*

In all the calcarenite stone samples, cracking obtained by thermal shock aging appeared after 2 cycles. On some samples, the cracks were small and present only on one side while for the rest, the cracks were larger and affected two or more faces (figure 5).

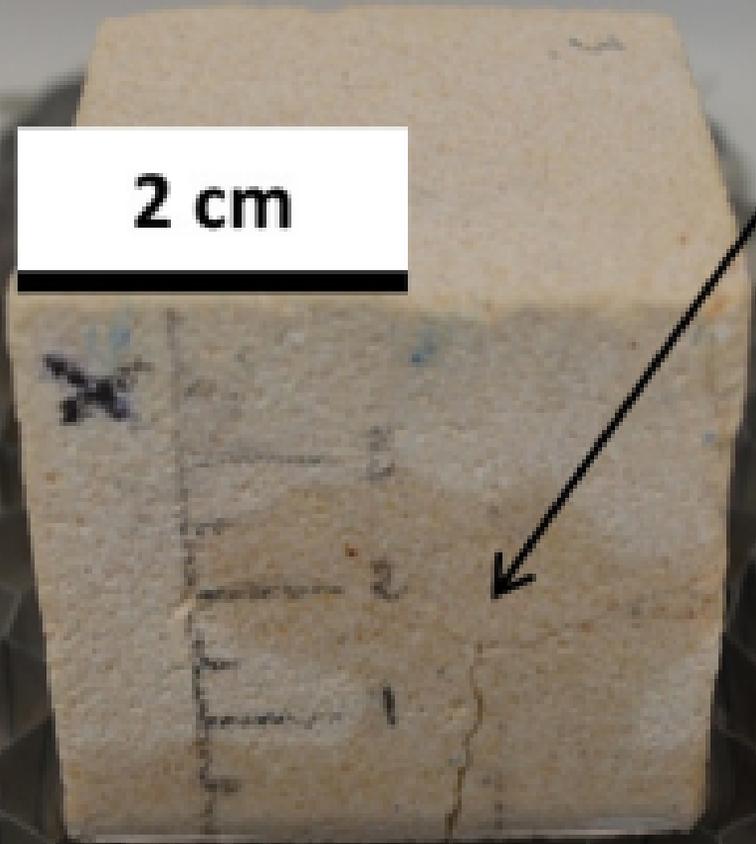
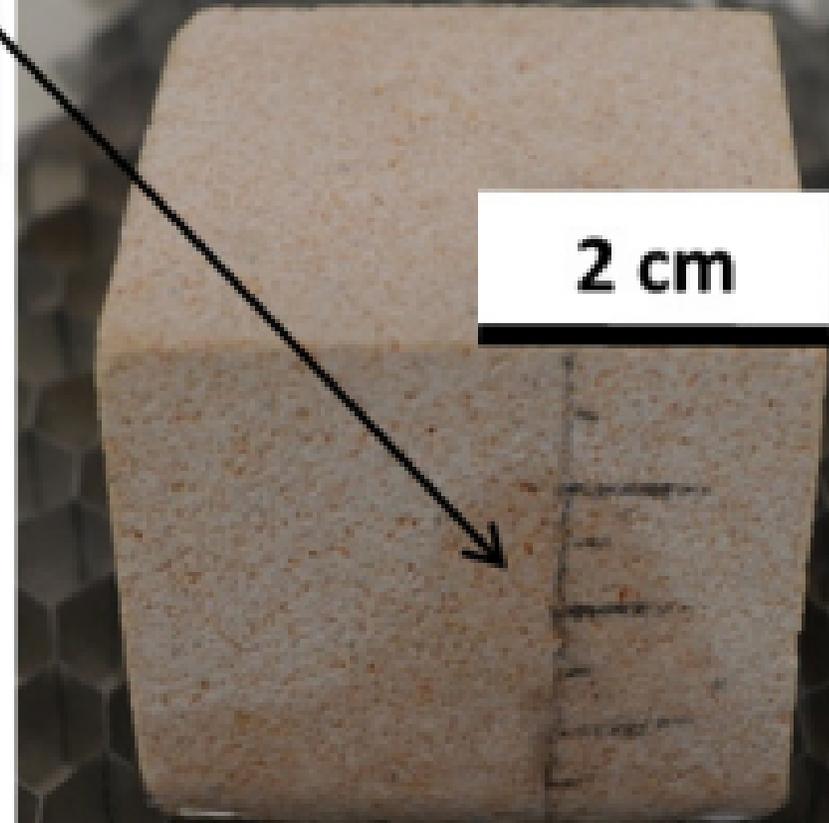
*Figure 6: Capillary imbibition curves of the most damaged sample (sample 3)*

Water rise in the  
cracks

The imbibition curve represents the evolution of the water uptake with the square root of time in the three directions of the cubic stone sample for the weathered sample (black curves) and treated samples (red curves). Compared to the unweathered stone (blue curve), the water uptake of the cracked samples in all three directions is much higher. When the imbibition was done through the cracked surfaces, the samples saturated much more quickly (after 30 minutes) compared to the non-degraded samples where the total saturation took on average 3 hours. Figure 7 shows that water rises faster in the cracks than in the non-cracked parts of the stone. Besides, the water content at the end of the test performed on the weathered sample was almost twice as high as the water content at the end of the test carried out on the unweathered sample.

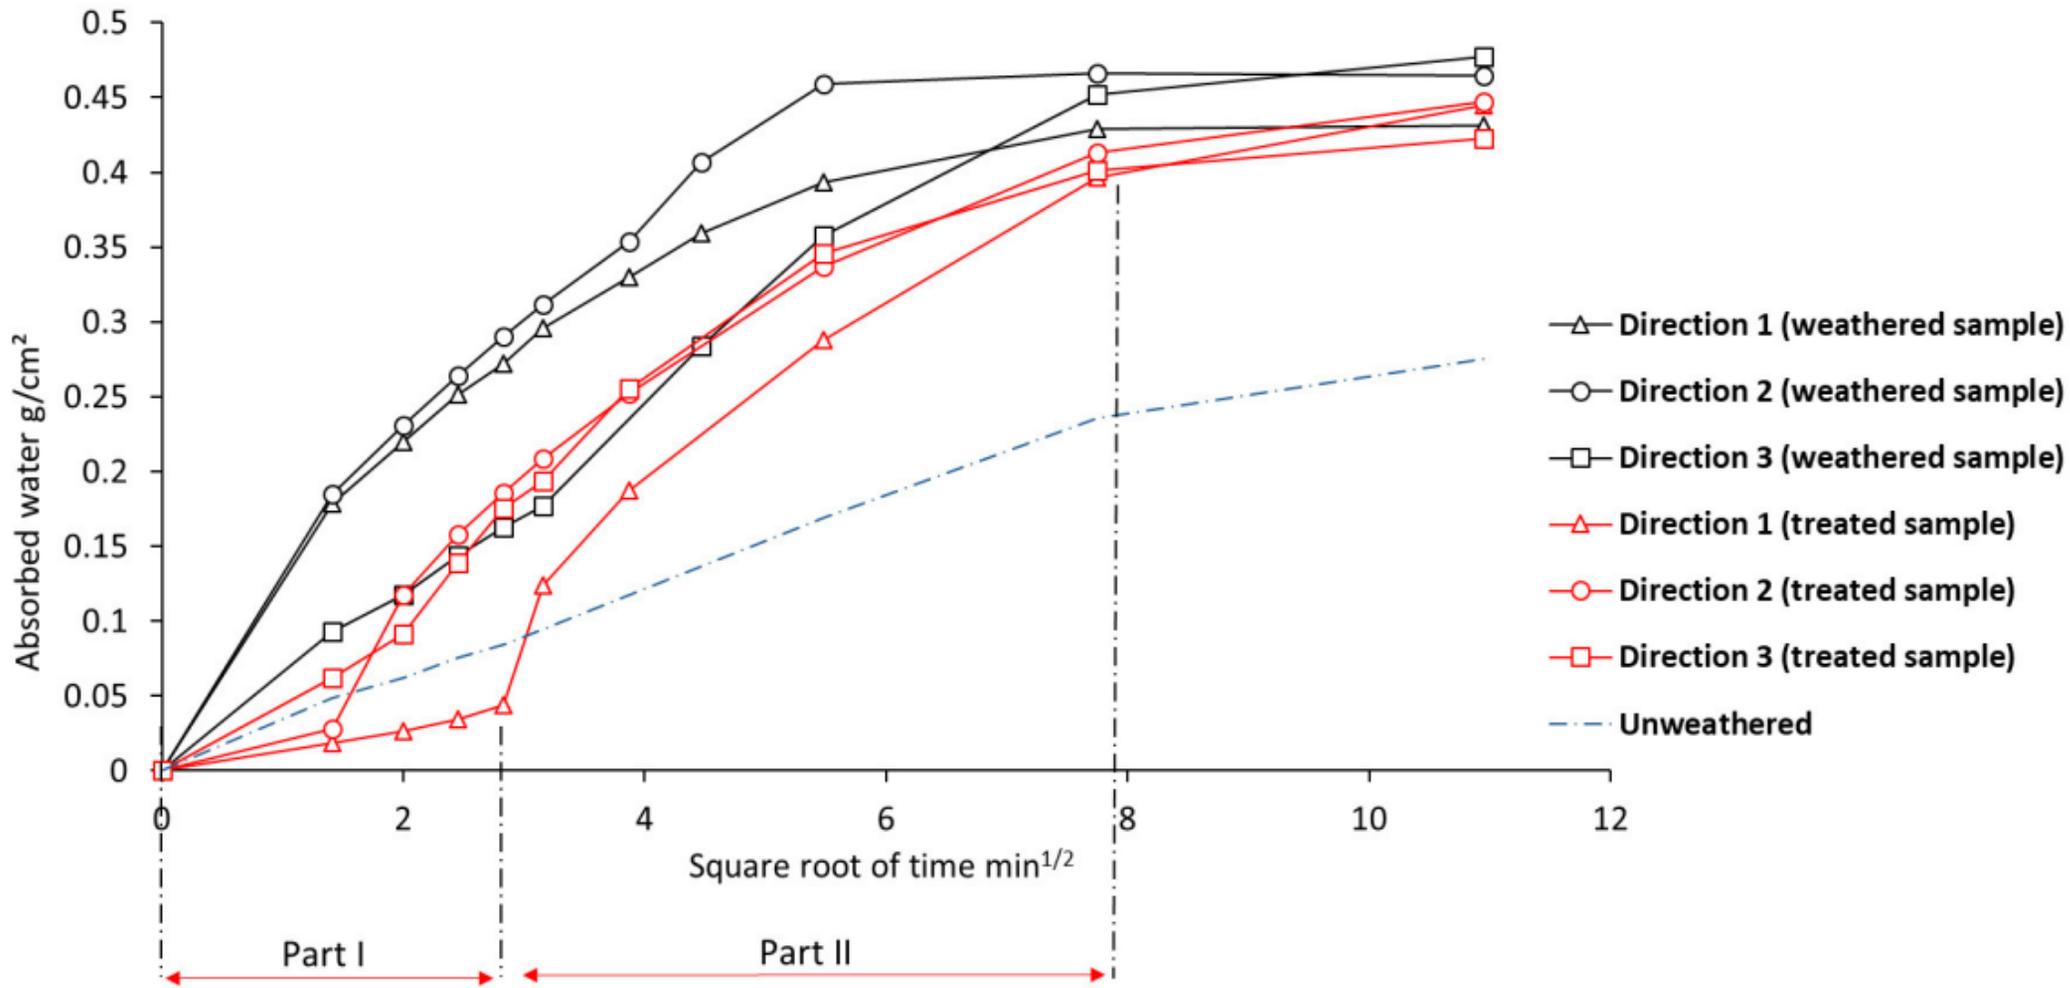
*Figure 7: Capillary imbibition of cracked samples (4×4×4 cm<sup>3</sup>)*

After treatment, a clear disturbance of the imbibition kinetics was observed. In the directions parallel to the cracks, the imbibition curve of the treated samples could be divided into two distinct parts. If we consider the imbibition curve done through the first direction of sample 3, as shown in figure 6, in the first (Part I), the curve is almost linear and has a much smaller slope than that of the imbibition curve of the unweathered sample, as a result of nanolime treatment and a partial saturation of the pore space with CaCO<sub>3</sub> particles. In the second (Part II), the slope of the curve increases drastically and becomes parallel to that of the cracked sample (table 2). However, in the directions perpendicular to the cracks, little to no change in the slope of the imbibition curve between part I and part II was observed given that the non-cracked faces of the sample were not treated.

In the directions parallel to the cracks, the abrupt change in the slope shows that the porous network of the stone was no longer homogeneous. The coefficient of imbibition of the treated part (Part I) was lower than that of the unweathered calcarenite stone. This might indicate that in addition to the cracks, the calcium carbonate particles were also deposited in the pores of the stone, causing a change in the pore space at the surface that was obstructed and consequently slowing the water rise in the sample. However, once the water goes past the treated part, the behavior of the stone is that of the weathered one. Beck [44] observed similar behavior when studying the evolution of the imbibition behavior of an artificially aged tuffeau limestone using the cyclic wetting-drying aging test described previously. The aging caused the appearance of a patina caused by the dissolution of calcium carbonate and its re-crystallization on the evaporation surface of the stone that slowed water movement only at the surface of the samples.

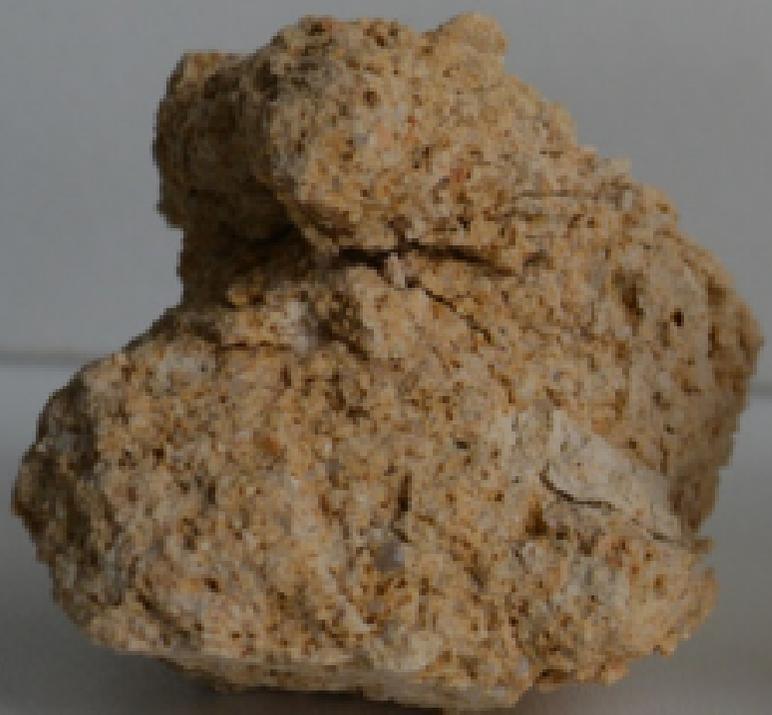
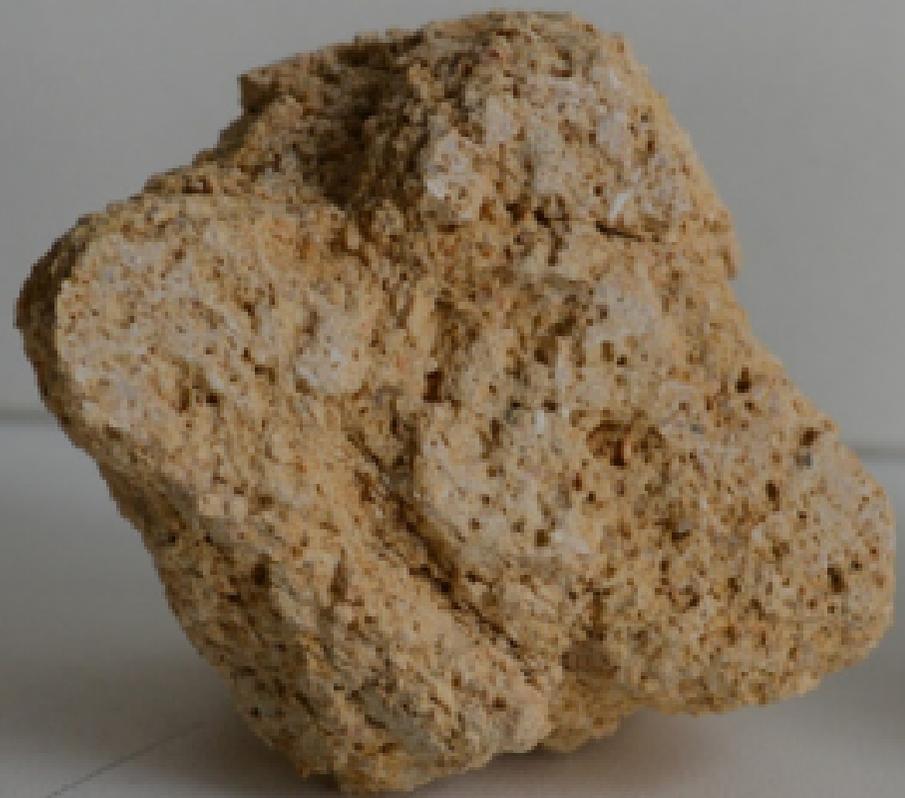
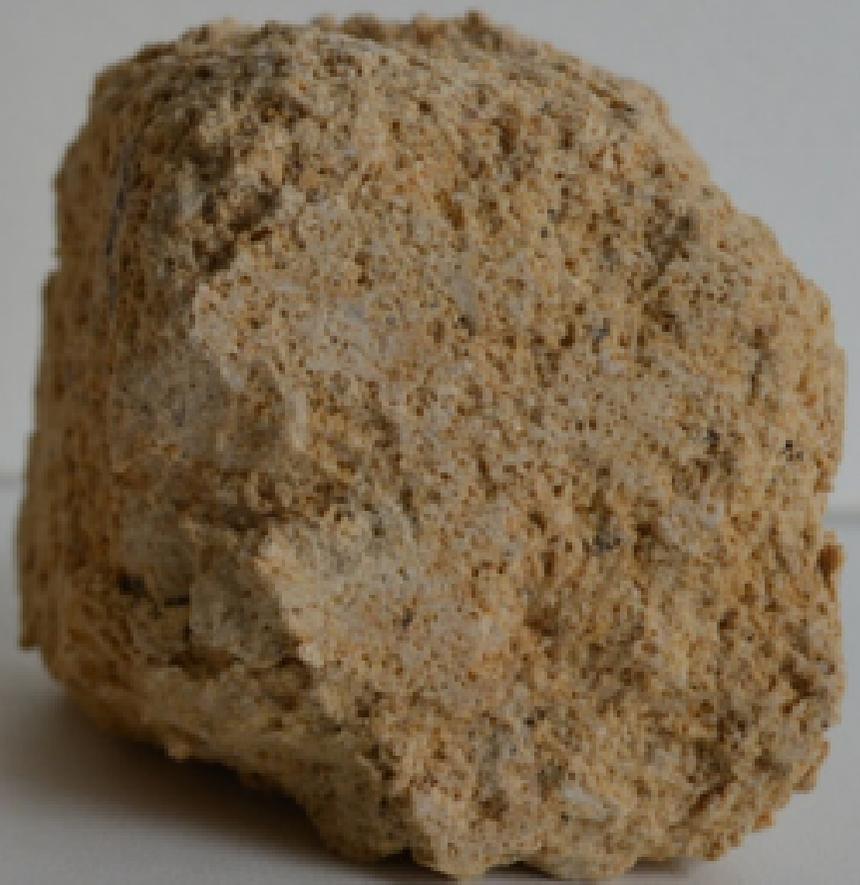
*Figure 8: Damaged calcarenite samples ( $4\times4\times4\text{ cm}^3$ ) after 15 cycles of the salt crystallization aging test*

The salt crystallization protocol caused degradation by the progressive loss of matter on the weathered surface, which is a very common kind of degradation found on the site. The protocol specified by the standard NF 12370 [33] recommends conducting the test for 15 cycles. However, the test was very destructive to the calcarenite stone. At the end of the test, the samples were too damaged to be treated (figure 8).

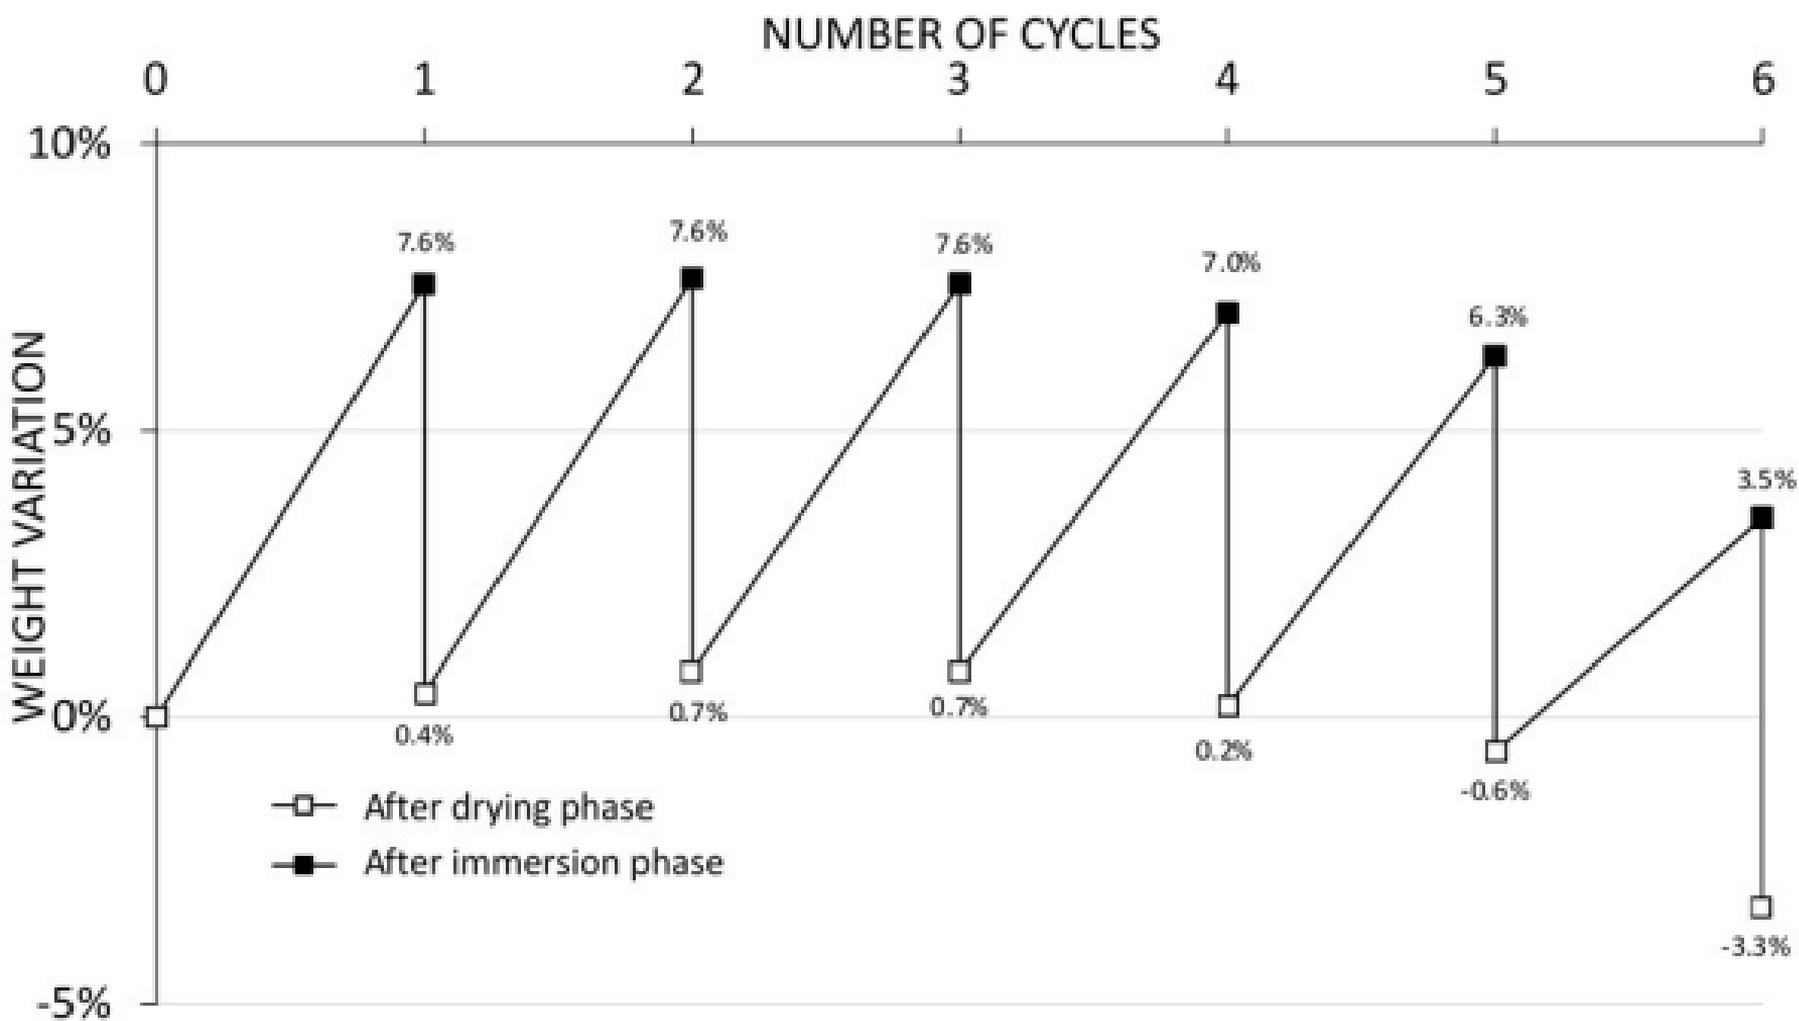
*Figure 9: Average weight variation during the first 6 cycles of the salt crystallization aging test [34]*

A second salt crystallization aging protocol was carried that was stopped at the 6<sup>th</sup> cycle, once visible damage with loss of material started to occur. The average weight variation of the samples during the salt crystallization test is presented in figure 9.

The average dry weight increased at the beginning of the test (during the first three cycles) as a result of the presence of the salt that precipitated in the pores of the tested samples. After that, the weight of the accumulated salt could not be balanced by the lost weight due to loss of surface matter [45], causing a decrease in weight from the fourth cycle on. Unlike the thermal shock protocols, the degradation induced by salt crystallization caused a loss of material. Alveolization was detected on the surface of the stone, resulting from the weathering of the yellow parts by sanding while the white parts remained intact (figure 10). The high percentage of macropores (52%), responsible for the capillary rise phenomenon [46], allowed the stone to absorb high quantities of the saline solution. In addition to that, and according to Zehnder & al. [47], crystallization originates in larger pores (macropores) that are connected to smaller ones (mesopores), causing damage to the stone. This indicates that the macropores are more concentrated in the yellow parts than in the white parts of the stone, visibly more porous. Once they were damaged, the treatment was applied to all the damaged faces of the calcarenite samples. The samples were weighed before and after each application to determine the quantity of nanolime absorbed as well as the variation in the dry weight of the specimens.

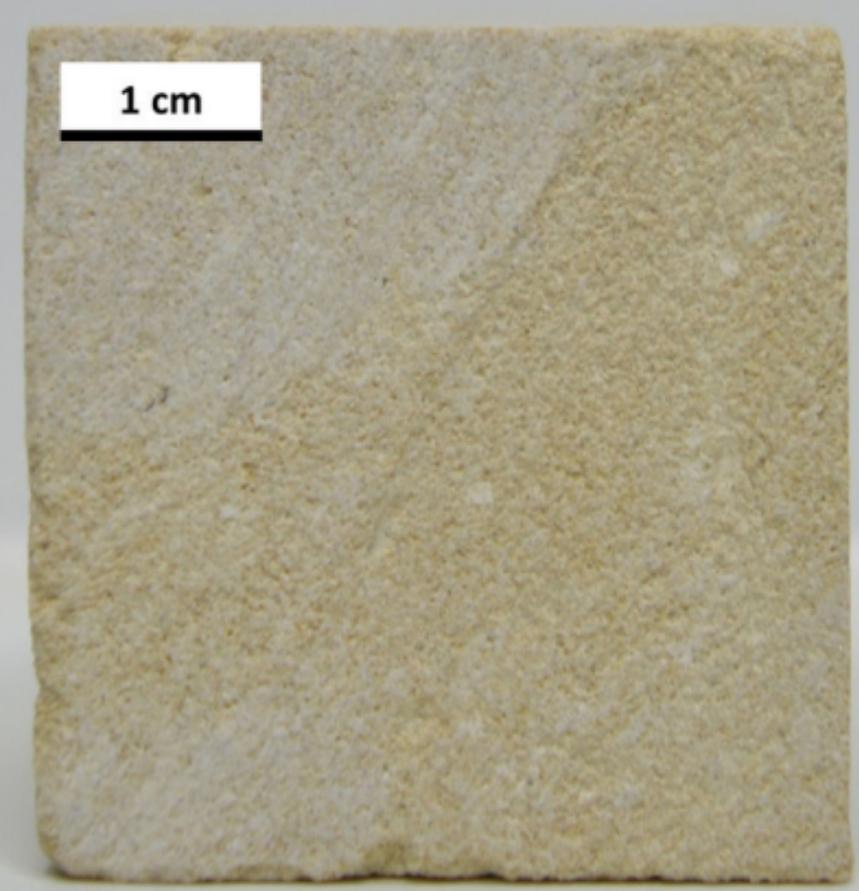
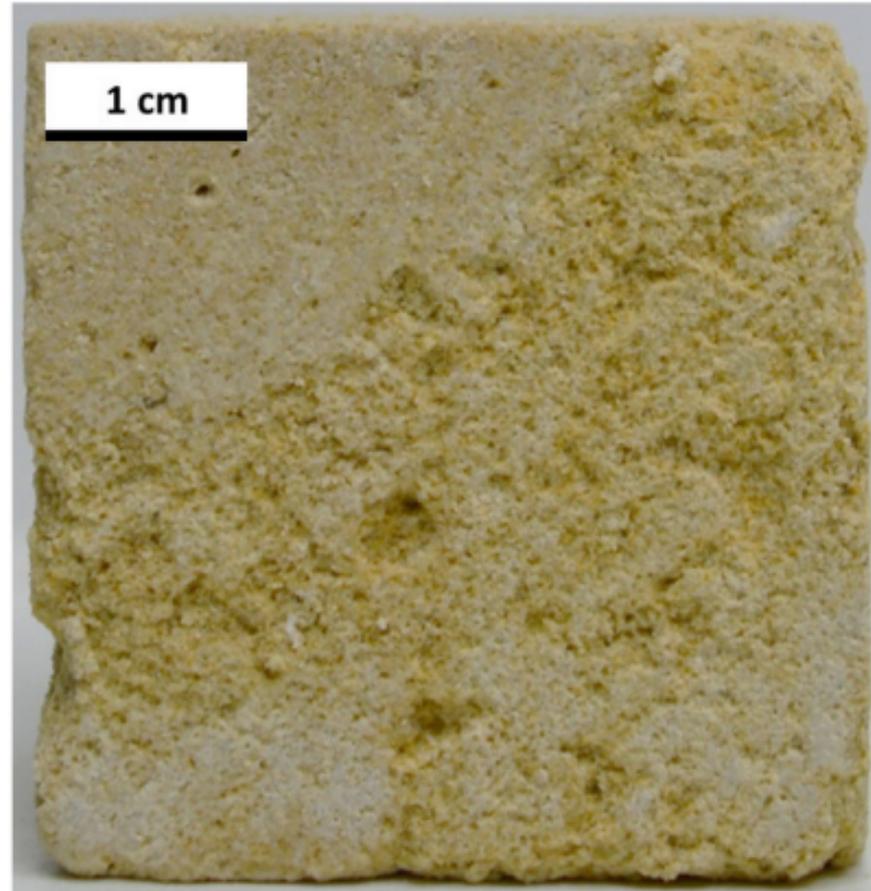
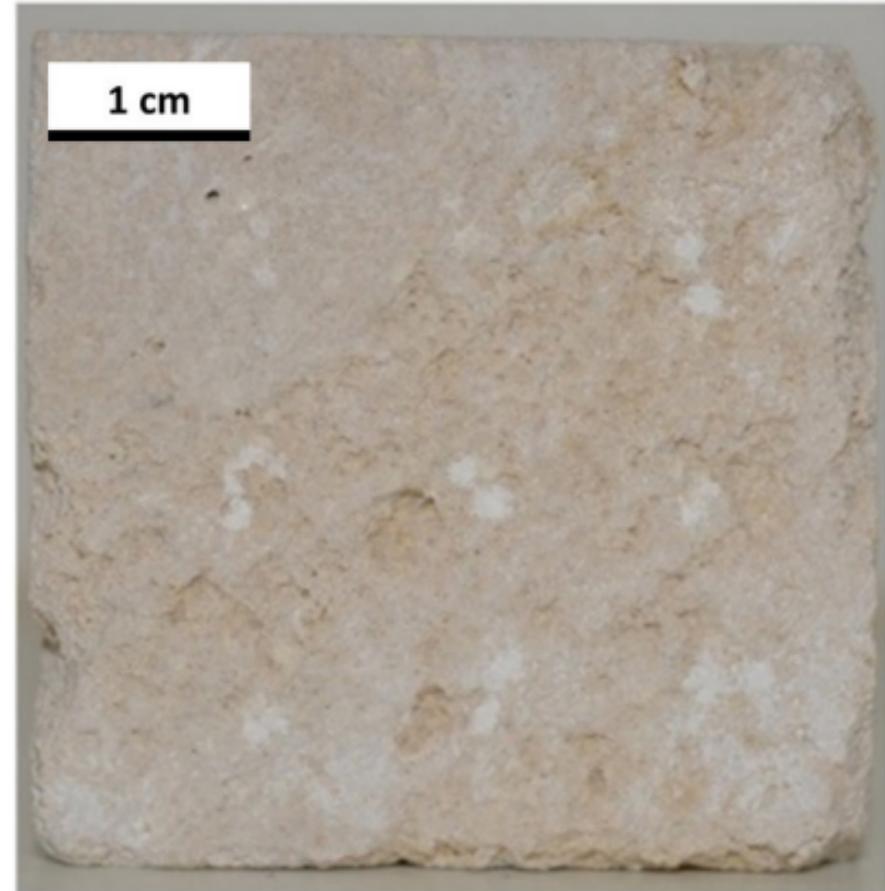
*Figure 10: Calcarenite stone sample ( $4\times4\times4\text{ cm}^3$ ) (a) before, (b) after the second salt crystallization test and (c) after treatment with nanolime*

The salt crystallization aging test caused a decrease in the L\* coordinates and an increase in the a\* and b\* coordinates. This means that the samples were darker, redder and more yellow. After the treatment, an increase in the L\* value for all the samples was noticed, which implies a lightening of all the samples that was due to the white haze observed on the surface of the stones, as a part of the nanolime absorbed had actually settled on the surface (figure 10).
