## Nanolime consolidation of the main building stone of the archaeological site of Volubilis (Morocco)

Dalal Badreddine, Kévin Beck, Xavier Brunetaud, Ali Chaaba, Muzahim Al-Mukhtar

Dalal Badreddine, Kévin Beck, Xavier Brunetaud, Ali Chaaba, Muzahim Al-Mukhtar. Nanolime consolidation of the main building stone of the archaeological site of Volubilis (Morocco). *Journal of Cultural Heritage*, 2020, 10.1016/j.culher.2019.12.006 . hal-02476671

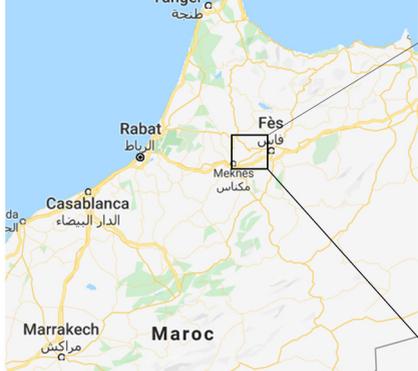
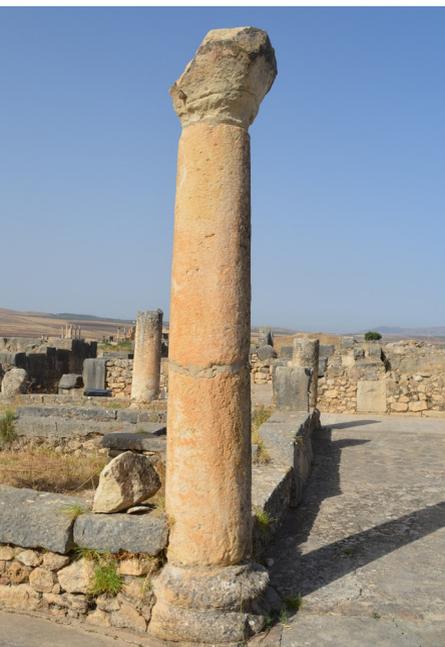
*Figure 1: (a) Geographical location of the archeological site of Volubilis, (b) calcarenite stone used as wall rubble and (c) as carved architectural elements*

The main objective of this research was to study the efficiency of nanolime as a consolidation treatment of a weathered limestone called calcarenite. Calcarenite is the main building stone of the archeological site of Volubilis, a world heritage site [1] located 30 km north of Meknes city in Morocco (figure 1).

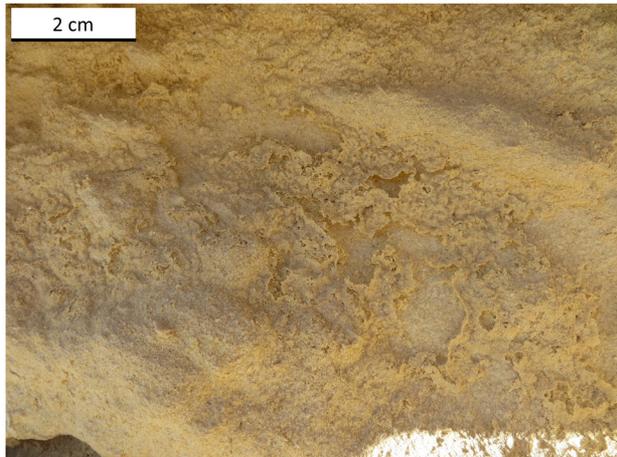
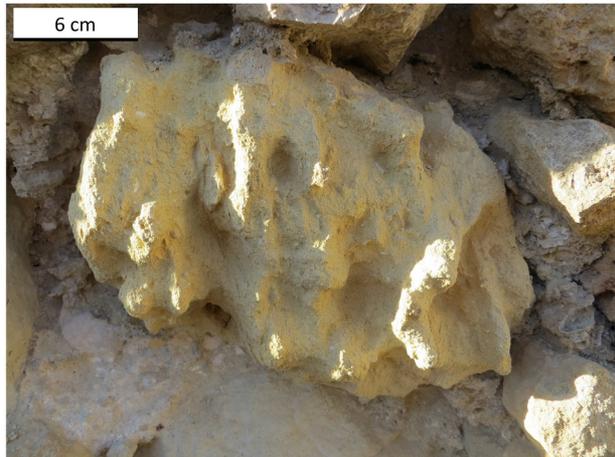
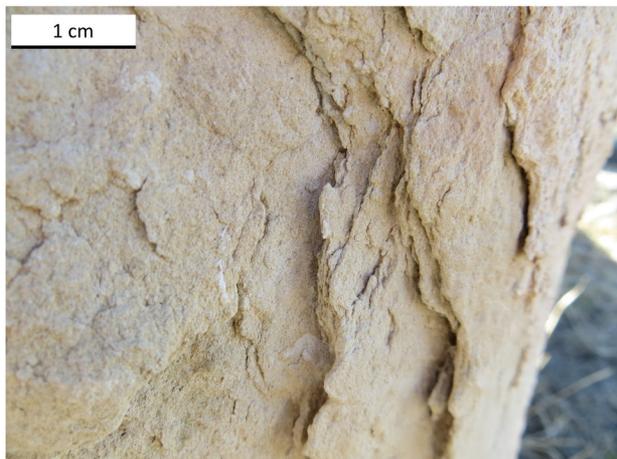
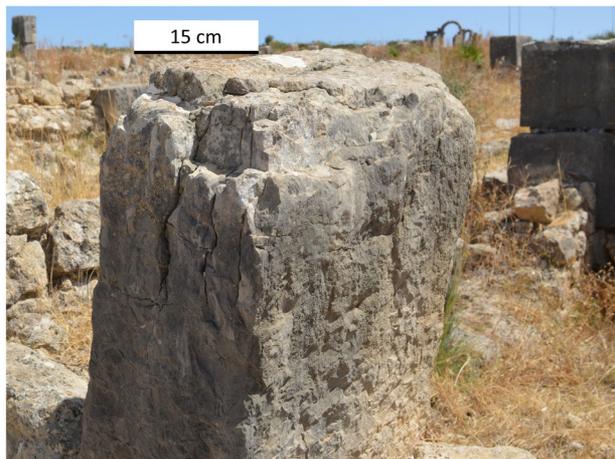
*Figure 2: Degradation patterns on the site of Volubilis*

Sanding

Alveolization

Scaling

Cracking

Over the years, exposure to aggressive environmental conditions has caused substantial damage to the site's monuments. The damage has affected the site on two levels: structural disorders that occurred after the Lisbon earthquake in 1755 [2], which caused the collapse of most of the monuments, and disorders that affect the building materials (stones and mortar). According to the ICOMOS glossary-illustrated figures of alterations of the stone [3], the degradation patterns observed in situ can be divided into two categories: biological colonization that alters the aesthetic aspect of the stone and degradation patterns that cause a loss of matter. The latter includes sanding, scaling and alveolization that are due to the crystallization of destructive salts originated in some of the restoration mortars and transported to the stone porosity by water transfer [4], as well as cracking that is caused by climatic variations [5].

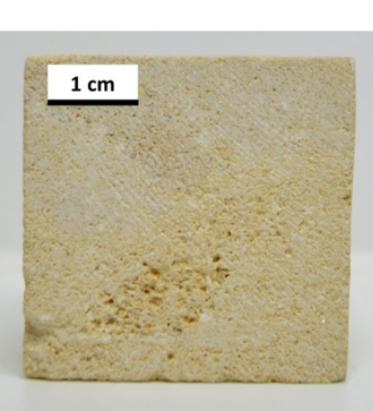
*Figure 3: (a) Calcarenite stone from Ain Schkor quarry (cubic sample  $4\times 4\times 4\text{ cm}^3$ ), (b) microscopic image of the calcarenite ( $\times 1000$ ) and (c) pore size distribution of the calcarenite stone*

Calcarenite stone is the main building stone of the archeological site of Volubilis, representing over 60% of the volume of the site's building stones. It was usually recovered from Ain Schkor quarry, located within 5 km of the site. Calcarenite is a beige-yellowish limestone rich in terrigenous material and large bioclasts [24] containing mostly calcite and quartz [4]. The stone has an average porosity of 19%, close to that of the San Julian calcarenite [25] and lower than other calcarenite like the Maastricht calcarenite (40 to 52% of porosity) [26], the Marsala calcarenite (40 to 60% of porosity) [27] or the Tamala calcarenite (30 to 50% of porosity) [28]. The calcarenite has a bimodal distribution with two distinct pore families: a first principal peak is observed around the pore diameter equal to 20  $\mu\text{m}$ , this type of pores represents the macroporosity, estimated at 52%. The second peak is between 0.1 and 0.3  $\mu\text{m}$ , this type of pores is the mesoporosity of the stone, estimated at less than 27%. The Calcarenite of Volubilis has a capillary coefficient of  $2.03 \text{ kg/m}^2/\text{h}^{0.5}$ , and compressive strength of 18.45 MPa. Compared to the previously cited calcarenites, the presently tested calcarenite has a higher compressive strength than the Marsala stone (1.2 to 4 MPa) [27], lower than the san Julian calcarenite (38 MPa) [29]. The Maastricht calcarenite has a wide compressive strength range (5 to 20 MPa) [30]. The presently studied calcarenite is visibly a heterogeneous stone, composed of two distinct parts: a yellow, visibly more porous, part and a white, more compact part (figure 3). Calcarenite has an average ultrasound velocity of 2751 m/s, but due to its apparent heterogeneity, it has an anisotropy index of 15% [31] which indicates that the velocity is higher in a certain direction. The microscopic image of the

calcarenite, taken with a scanning electron microscope Hitachi TM-3000, shows a compact matrix (formed of calcite) surrounding angular quartz grains with a diameter of approximately 100  $\mu\text{m}$  [31].

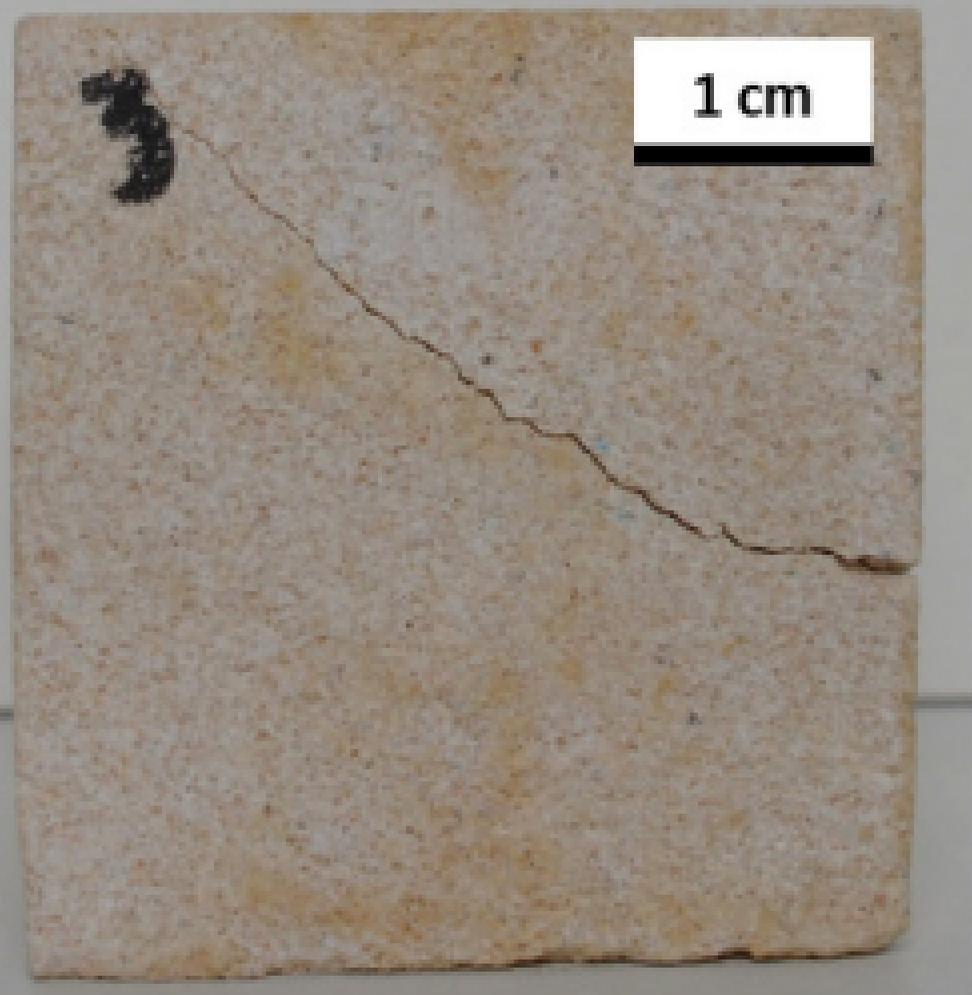
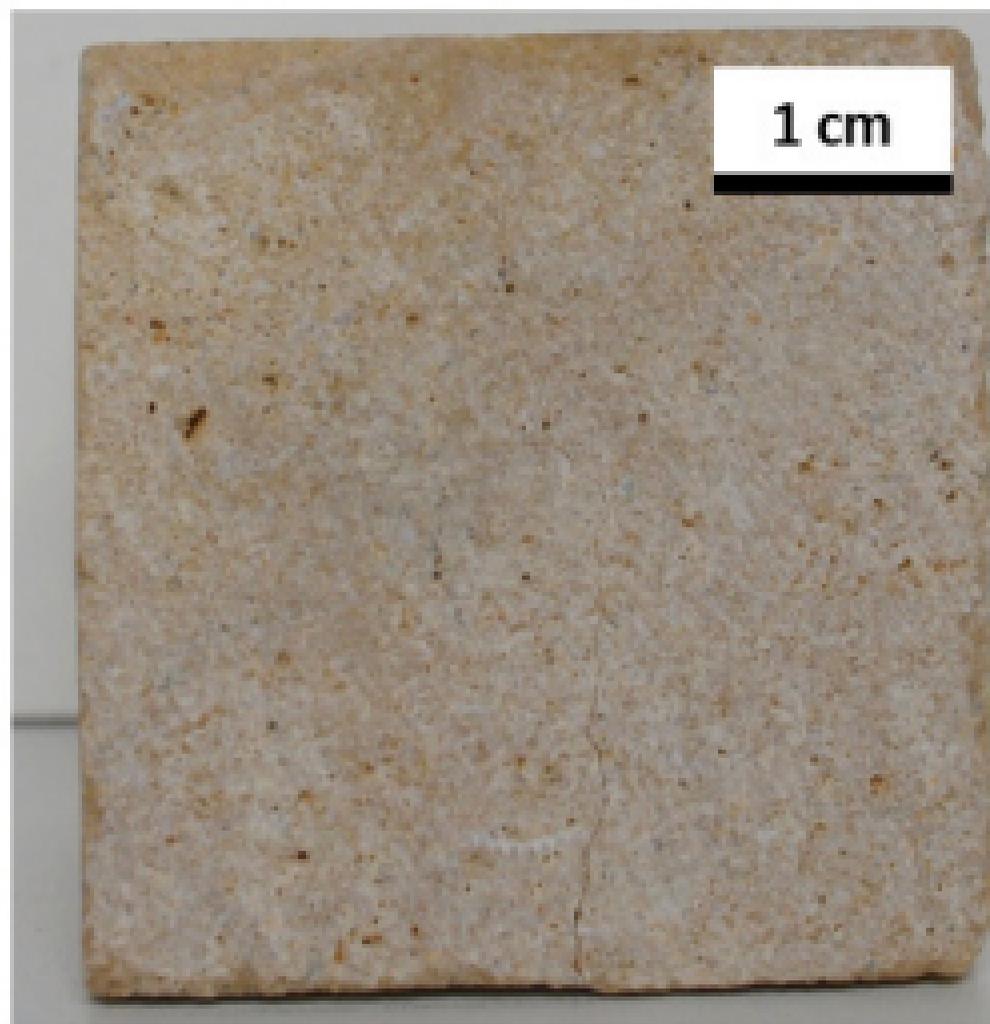
*Figure 5: Cracked calcarenite stone samples due to thermal shock aging test ( $4 \times 4 \times 4$  cm<sup>3</sup>)*

In all the calcarenite stone samples, cracking obtained by thermal shock aging appeared after 2 cycles. On some samples, the cracks were small and present only on one side while for the rest, the cracks were larger and affected two or more faces (figure 5).

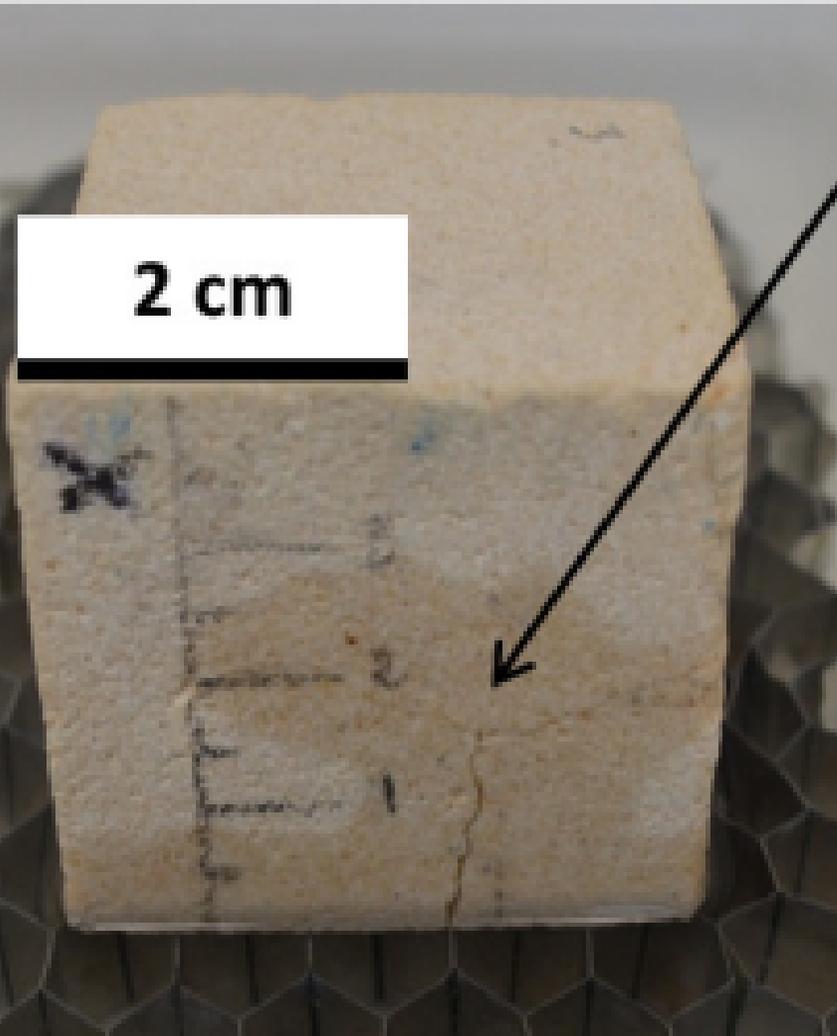
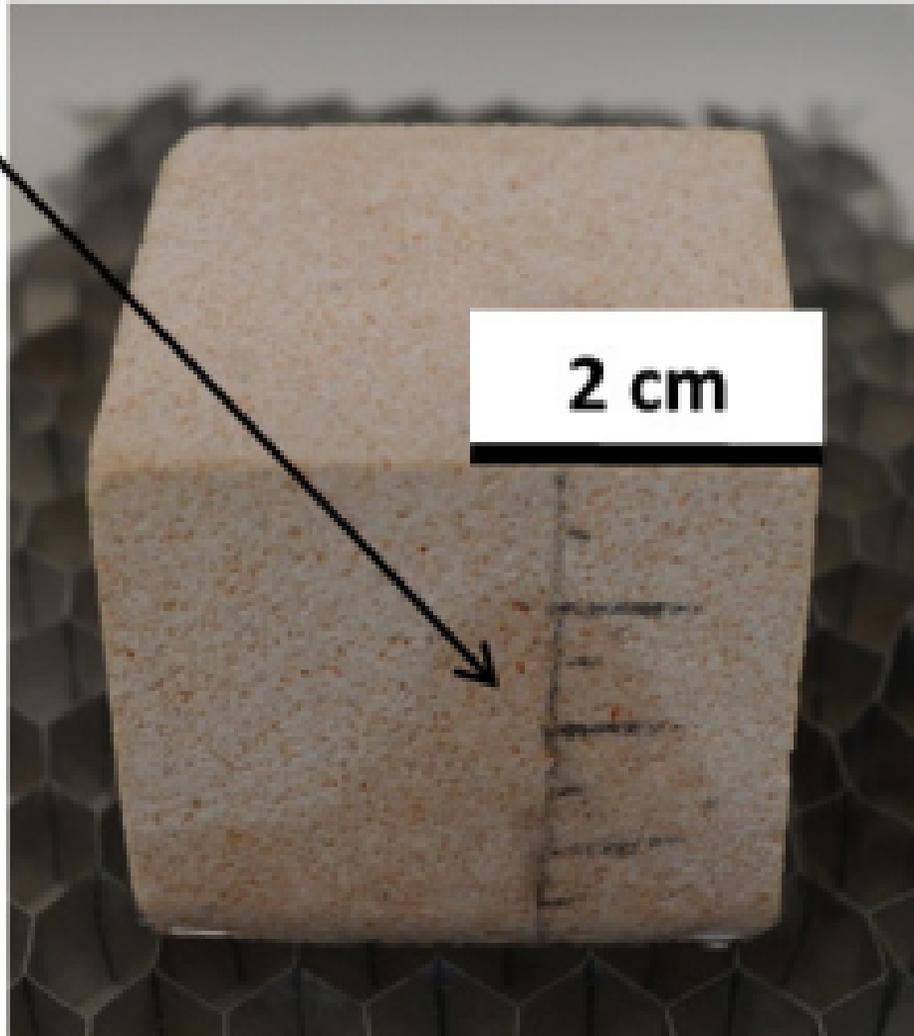
*Figure 6: Capillary imbibition curves of the most damaged sample (sample 3)*

Water rise in the cracks

The imbibition curve represents the evolution of the water uptake with the square root of time in the three directions of the cubic stone sample for the weathered sample (black curves) and treated samples (red curves). Compared to the unweathered stone (blue curve), the water uptake of the cracked samples in all three directions is much higher. When the imbibition was done through the cracked surfaces, the samples saturated much more quickly (after 30 minutes) compared to the non-degraded samples where the total saturation took on average 3 hours. Figure 7 shows that water rises faster in the cracks than in the non-cracked parts of the stone. Besides, the water content at the end of the test performed on the weathered sample was almost twice as high as the water content at the end of the test carried out on the unweathered sample.
